## **FACE INVESTIGATION**

### **SUBJECT: Florist Pinned Between Bucket of an Industrial Truck and Semi Trailer**

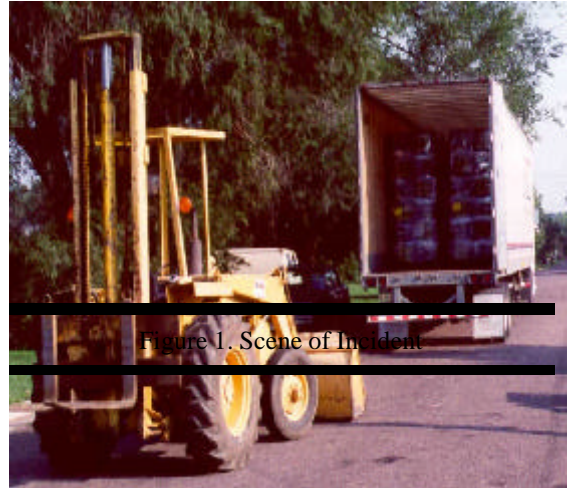
Figure 1. Scene of Incident

The co-worker had attached the chain to a pallet inside the truck, so the victim was ready to attach the chain to the bucket. He was standing in front of the trailer, but the chain didn't reach the bucket so he motioned to the operator to move forward a few inches. The loader lurched forward, pinning the victim between the bucket and the trailer. After several unsuccessful attempts, the operator backed the loader and the victim fell to the ground. The co-worker went to aid the victim while the operator called for emergency services. A police patrol car was in the neighborhood and responded within five minutes, and EMS services arrived soon after. The victim was transported to the hospital, where he died. An inspection of the loader after the incident revealed that after placing the machine in forward gear, it would take some time before the transmission fluid built enough pressure to move the machine. Then the machine would suddenly lurch forward and full force brake pressure would not stop the machine until it had traveled several feet. Mechanical brake adjustment on this loader can be achieved by tightening a bolt under the loader body.
